**Eastbound Platform**

March/September 21

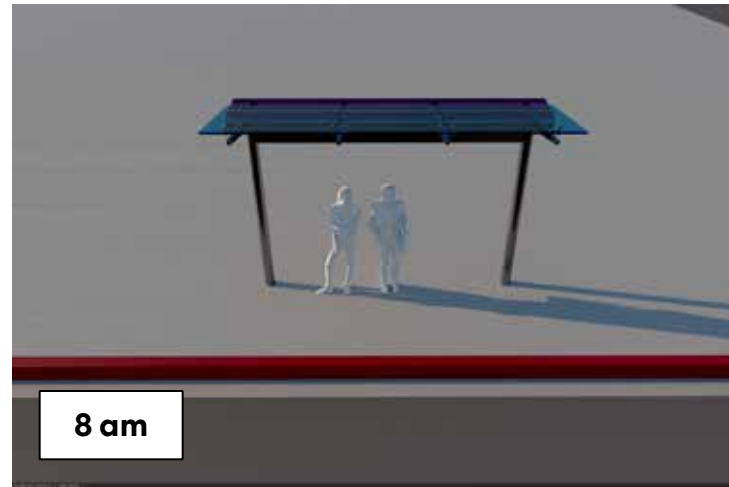
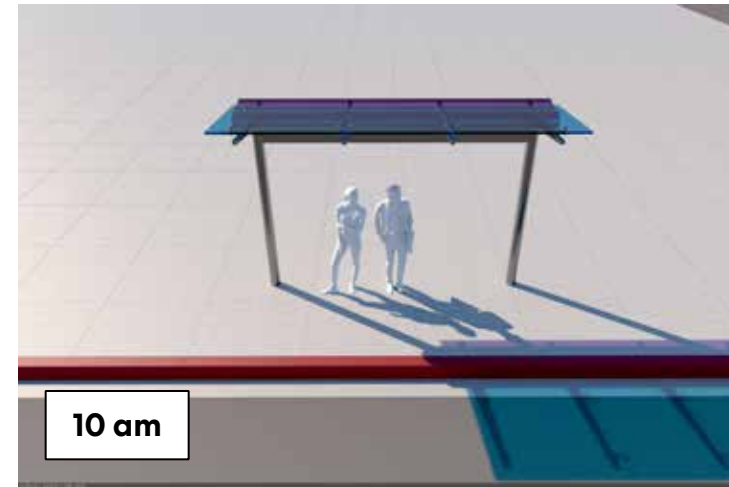
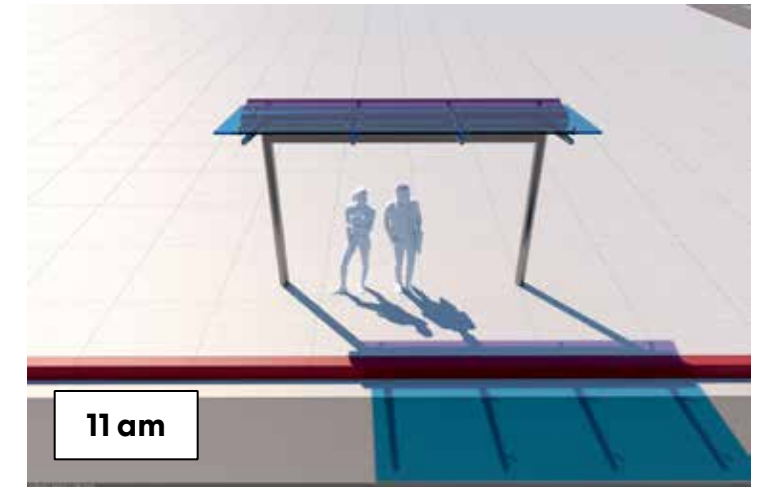
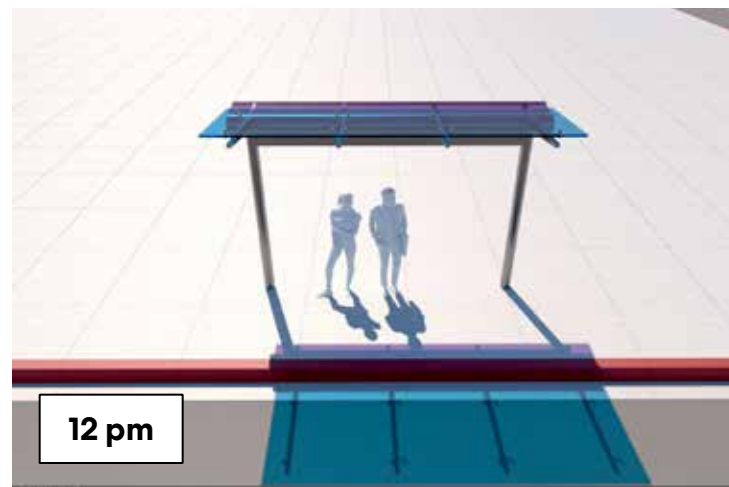
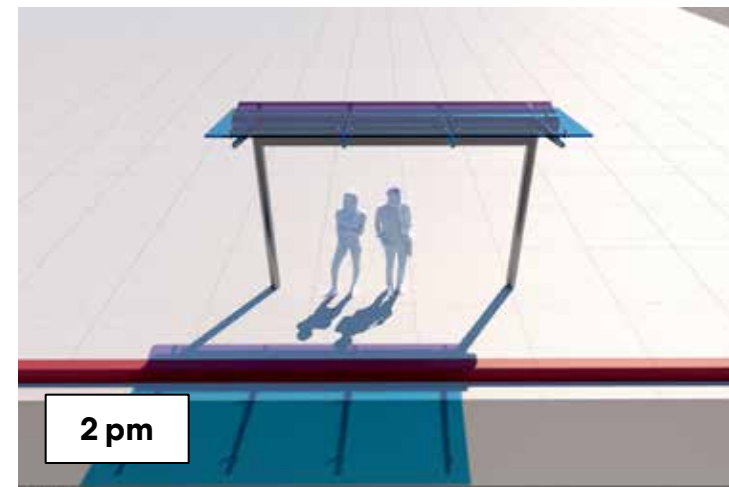
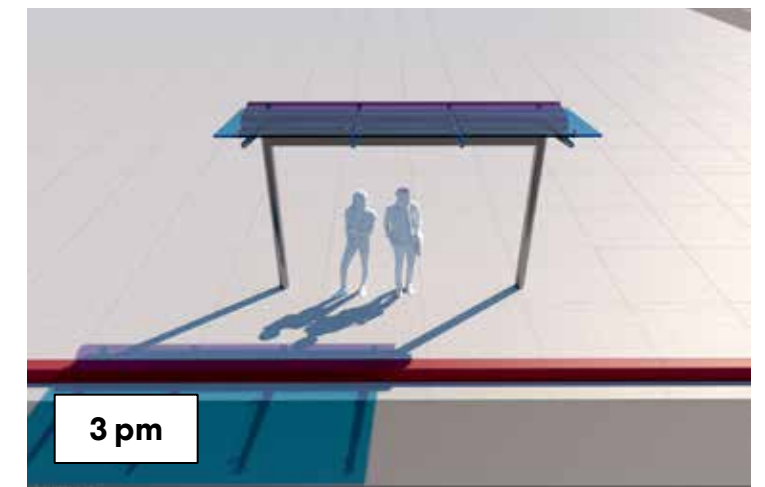
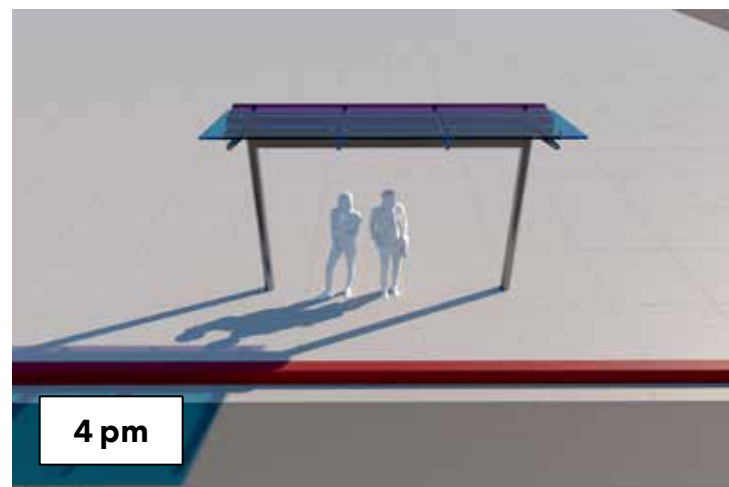
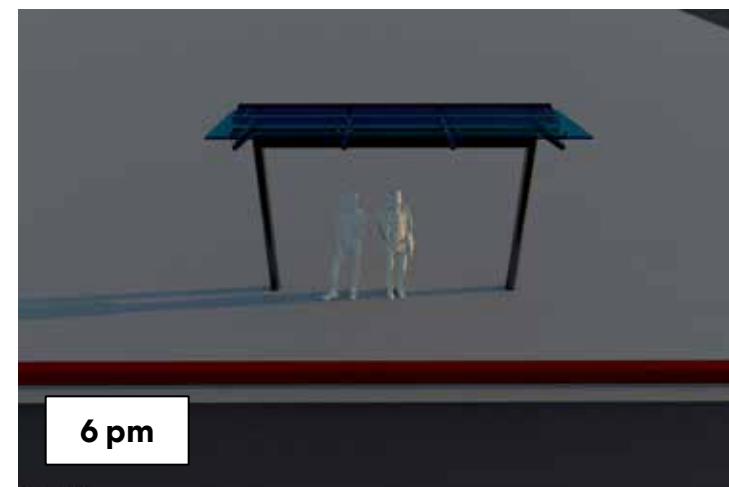
Images show the position of the shade provided by a standard bus shelter roof

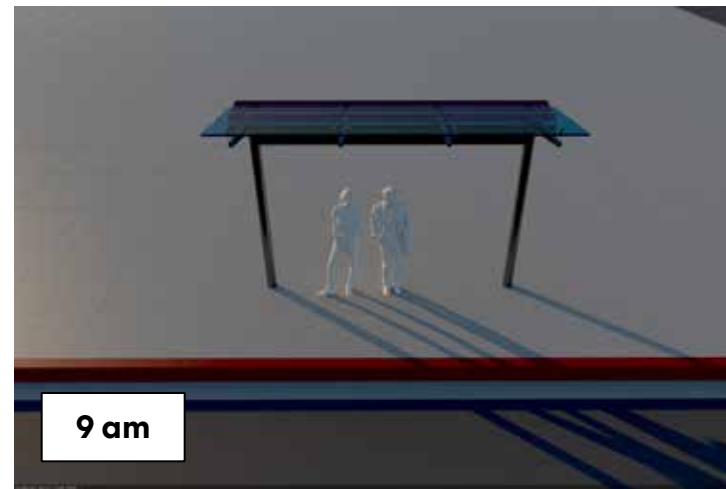
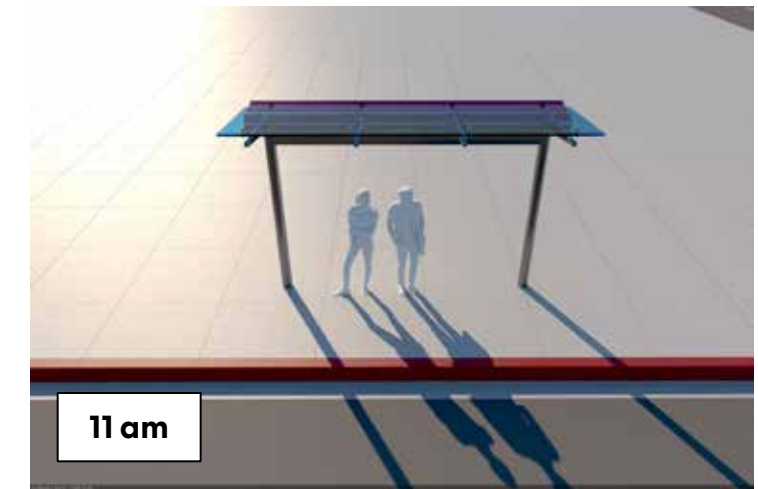
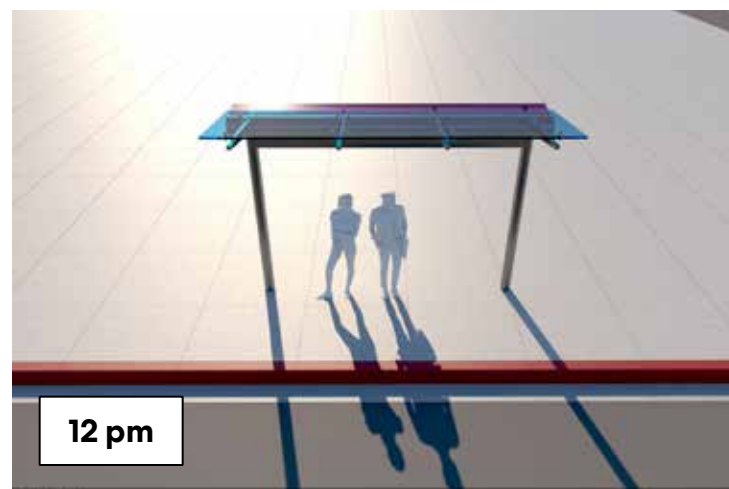
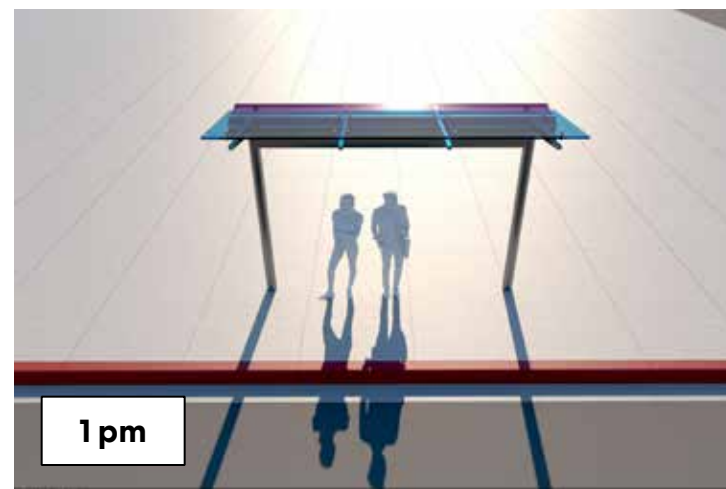
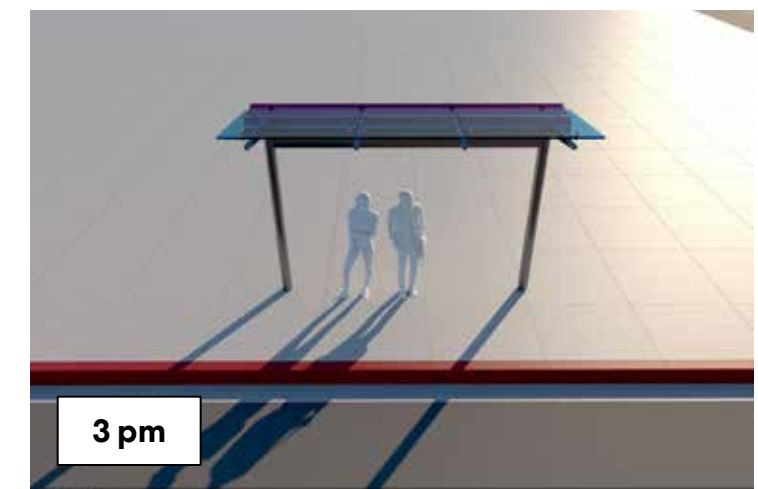
December 21

Images show the position of the shade provided by a standard bus shelter roof

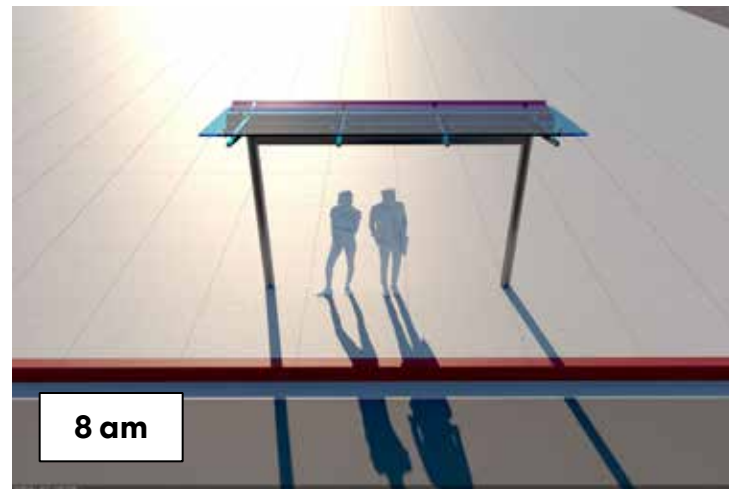
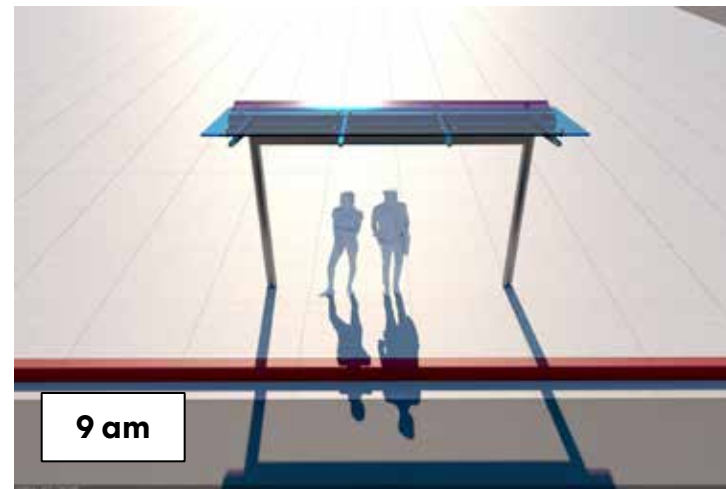
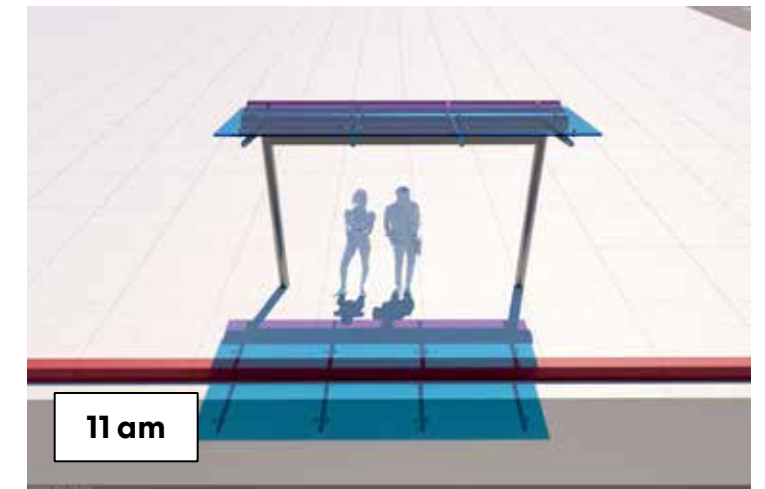
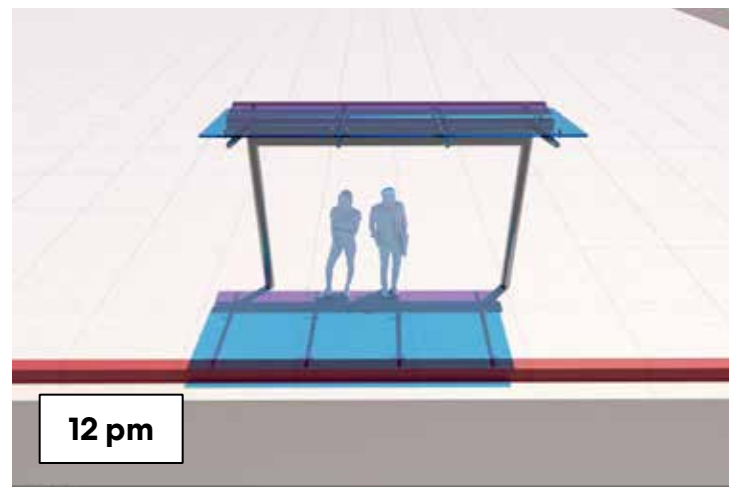
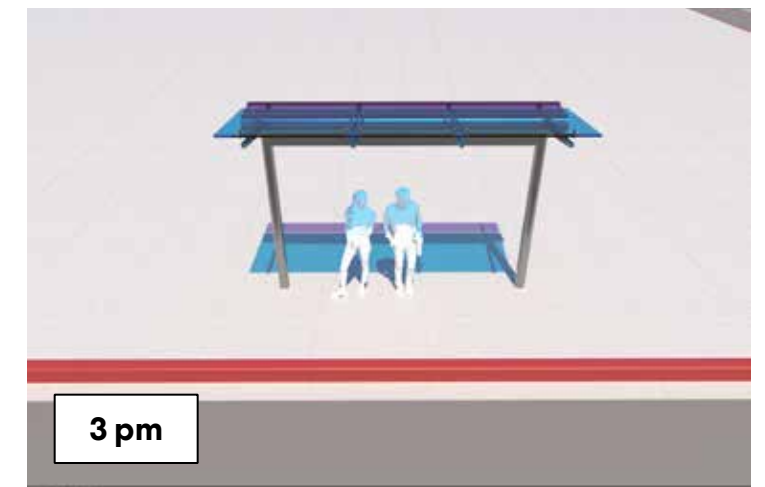
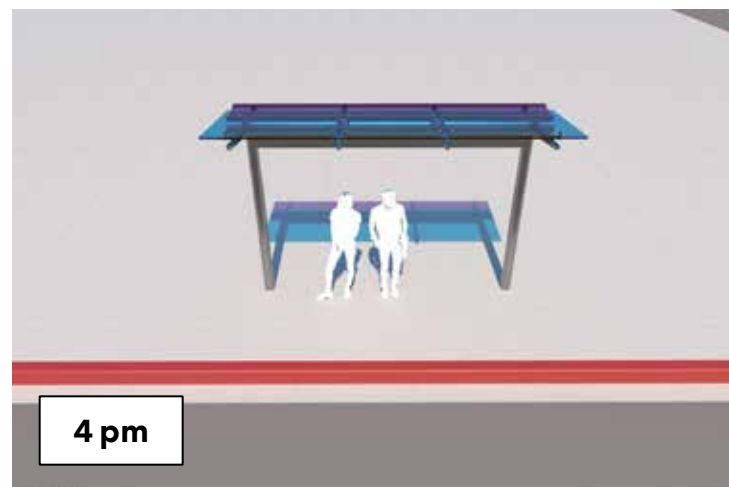
June 21

Images show the position of the shade provided by a standard bus shelter roof

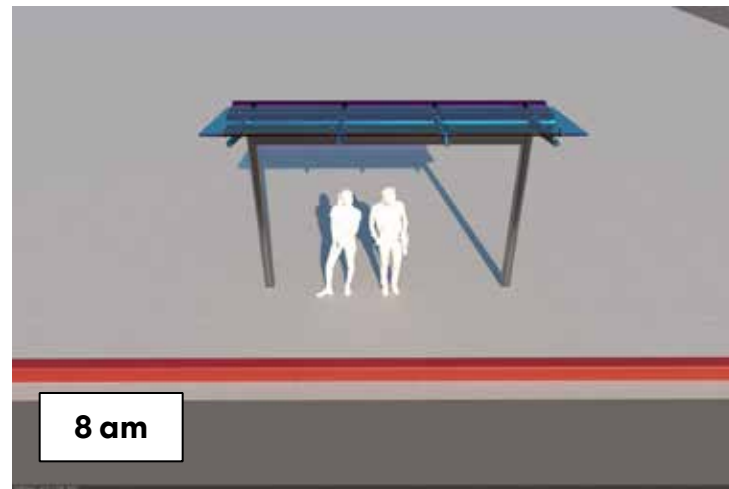
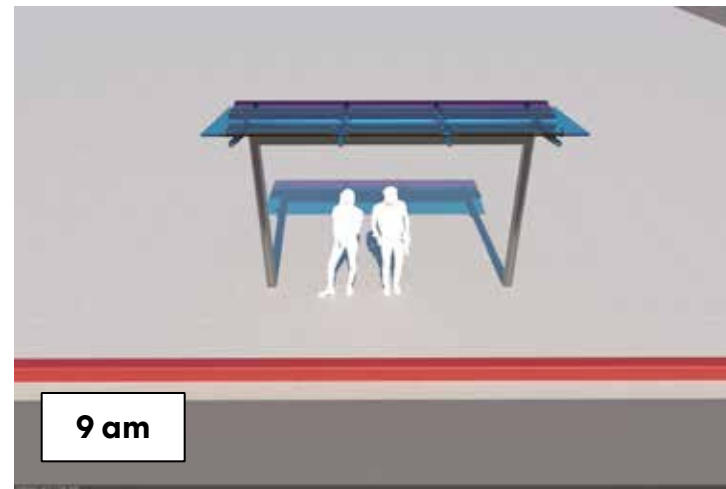
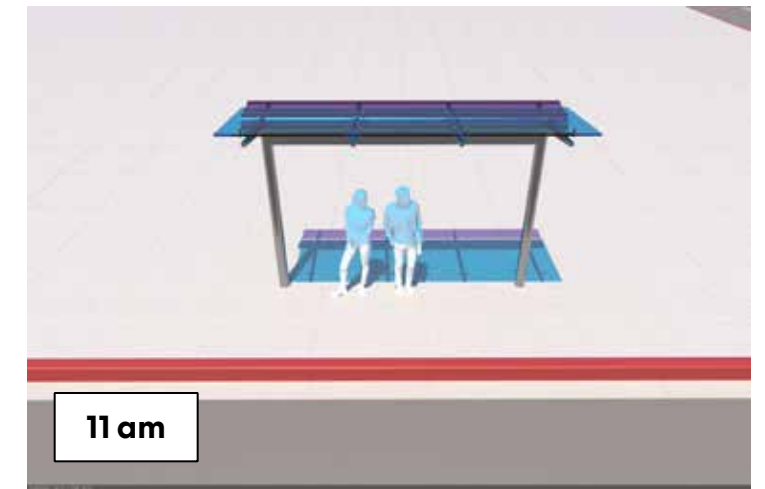
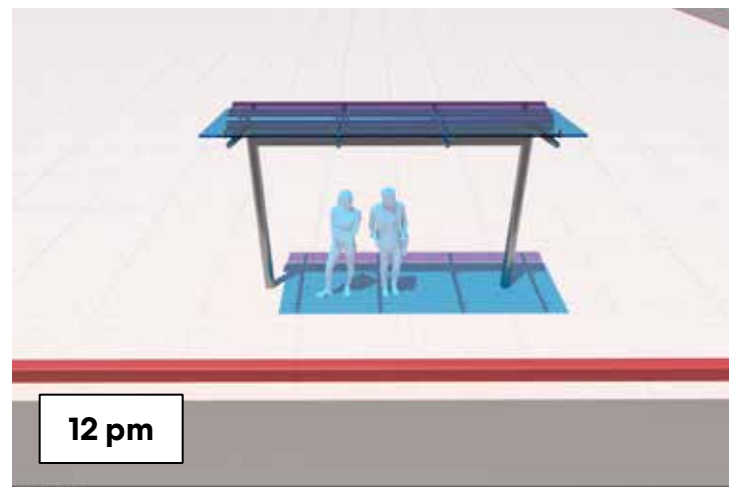
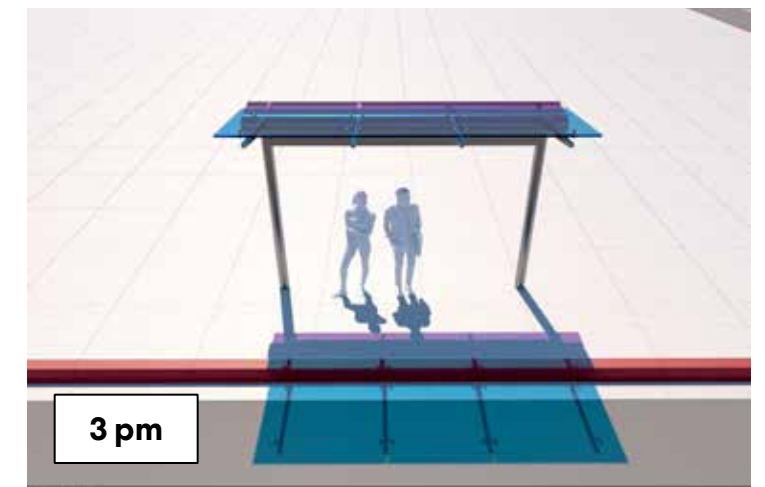
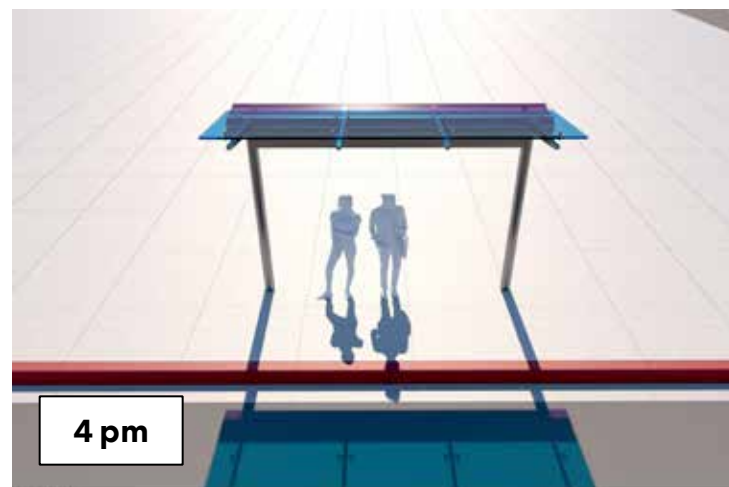
June 21

Images show the position of the shade provided by a standard bus shelter roof

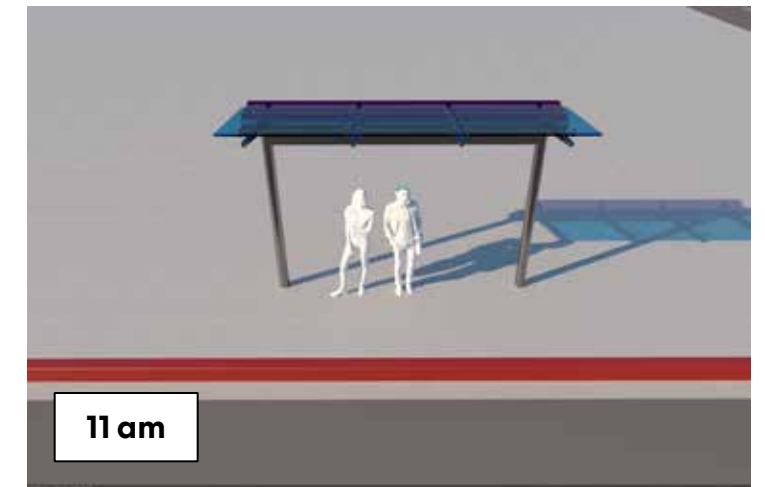
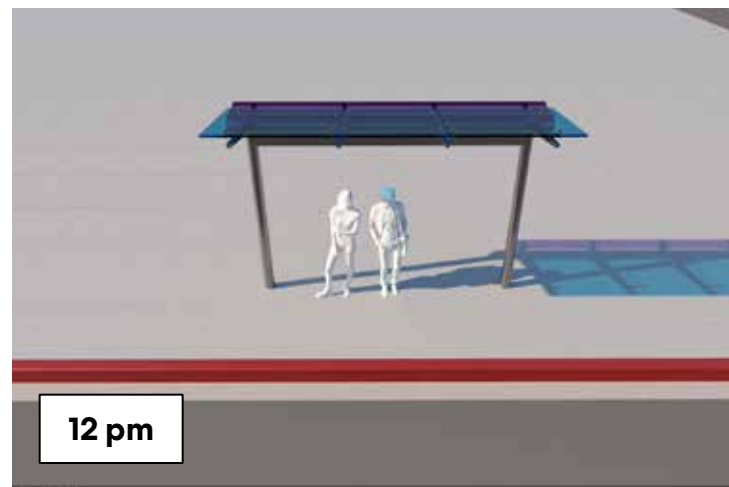
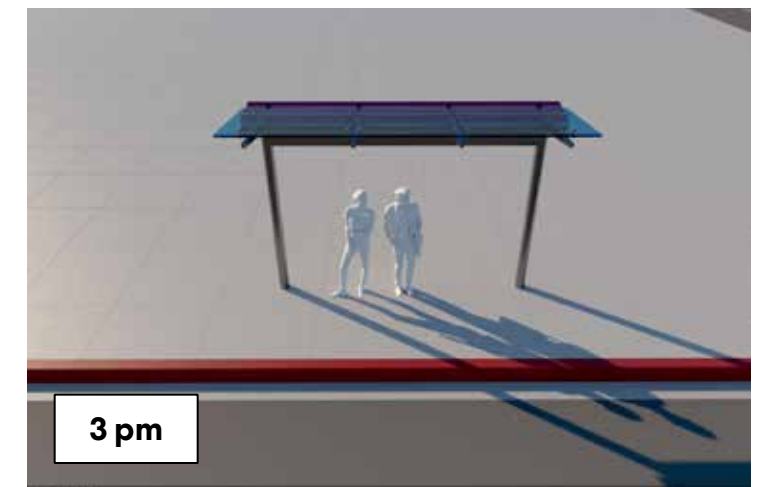
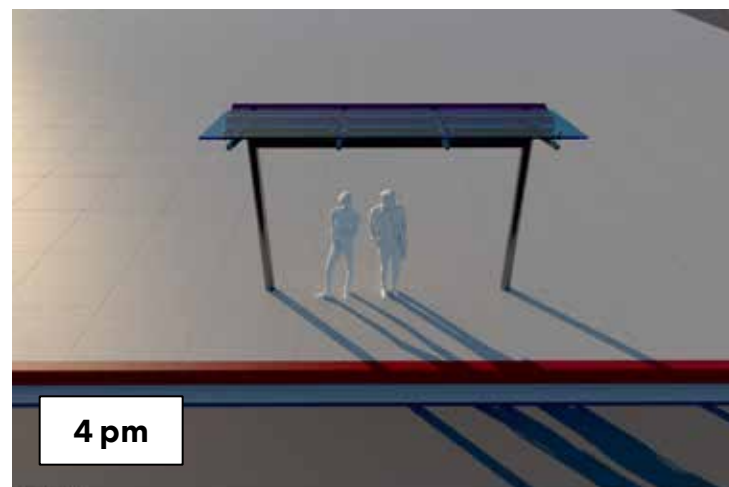
December 21

Images show the position of the shade provided by a standard bus shelter roof
